Appendix B

Room Descriptions

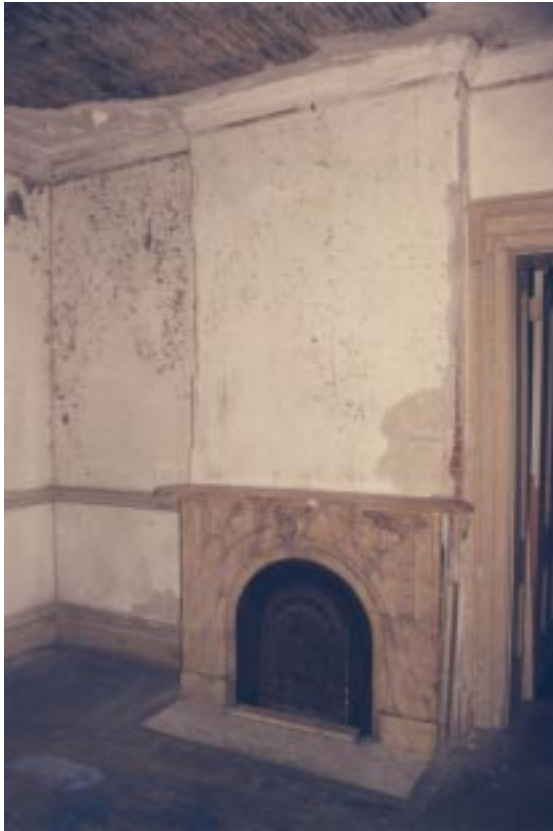
The Reception Room was used in 1850 perhaps as an office for the farm operations and later as a room in which to have intimate gatherings and conversation. The cornice is in relatively good condition, but does need attention and repair. The ceiling, on the other hand, will require extensive patching by the three-coat method.

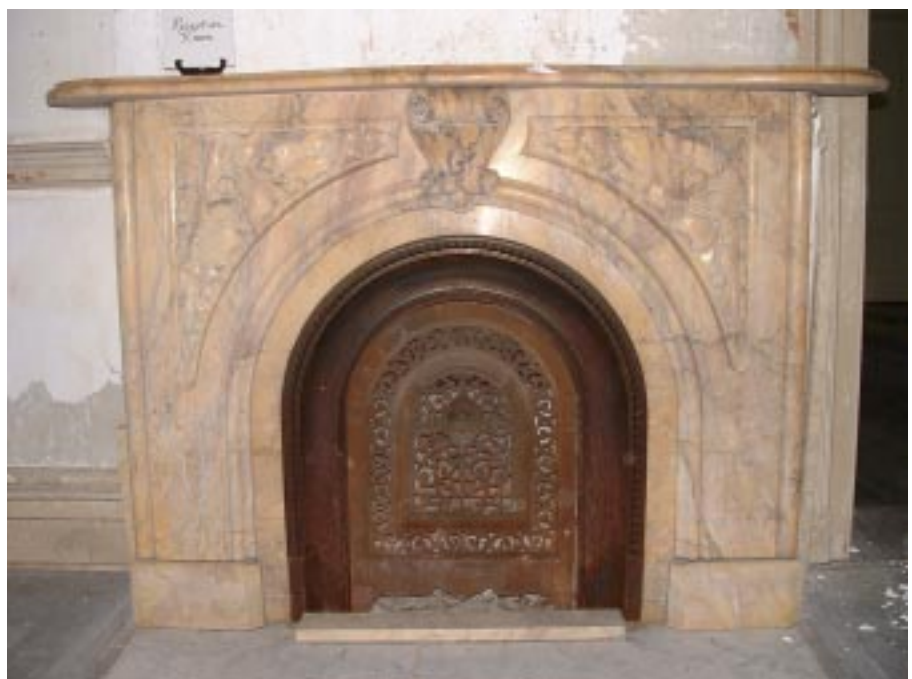
Close-up of Reception Room chimneypiece shows the delicate coloration of the marble, the mantel shelf, and the ornate cast-iron grate cover as well as the white marble hearth at the level of the original floor. Not visible in the photograph are the carvings in the recessed triangular areas. The side panels have both cracked in half, but the pieces remain and should be reinstalled.

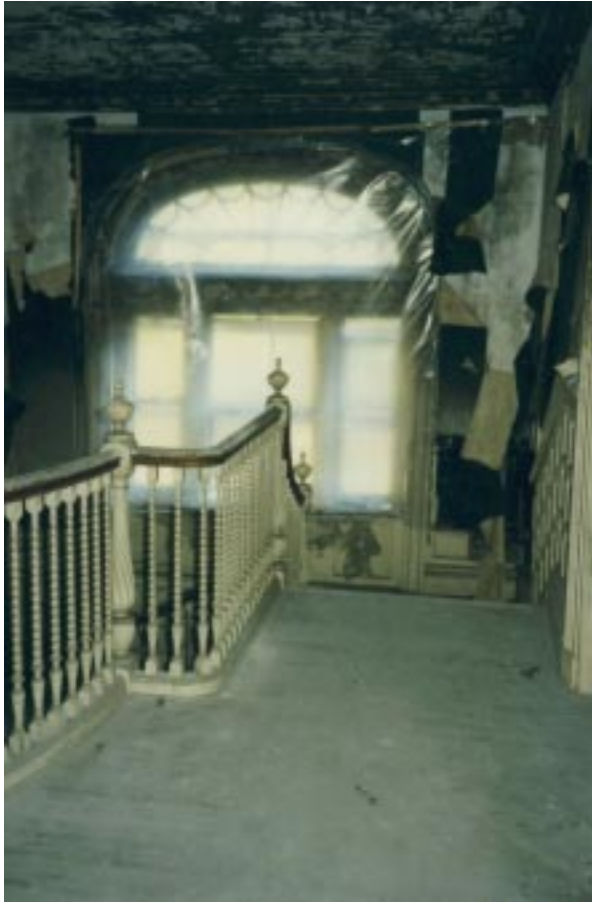
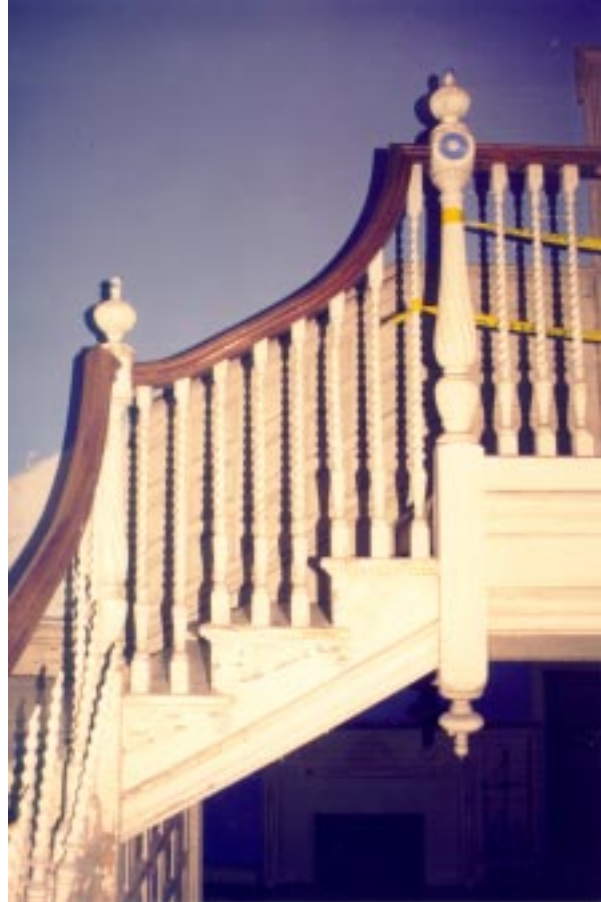
Right: The upper Stair Hall after the 1985 fire. The photographs illustrates the position of the tri-partite window at the turning of the staircase. Note the delicate tracery on the elliptical window. Left: A detail of the balustrade at the uppermost run of steps. Note the mirroring of the finials on the newel posts and the carving at the stair ends. Below: Detail of the window architrave .

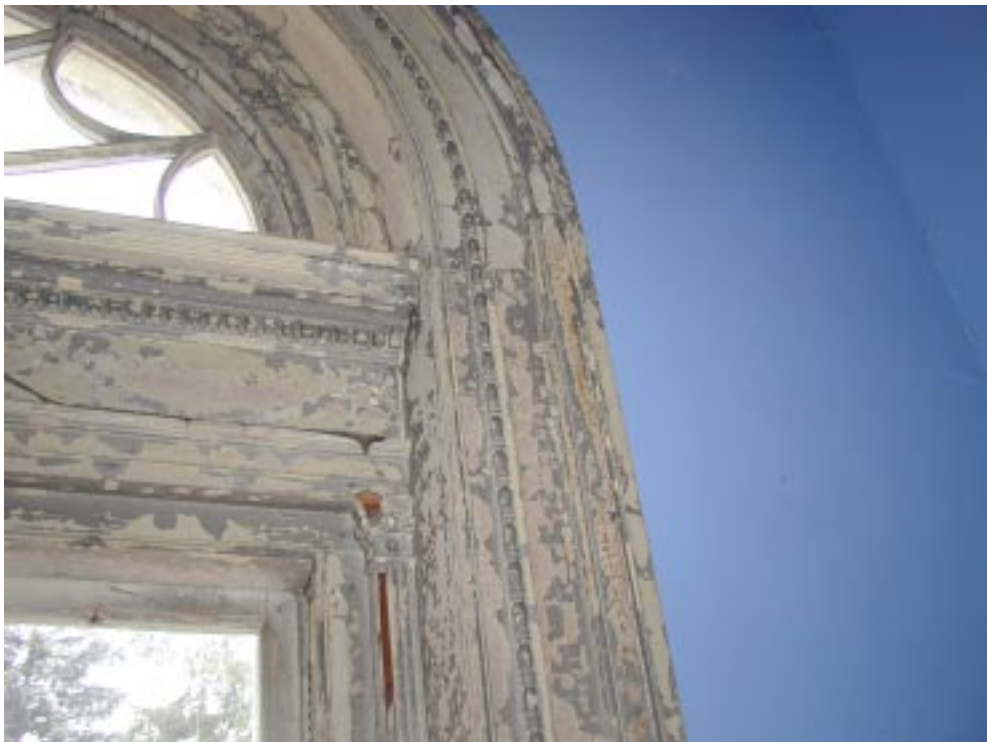
otherwise dark stair hall. The section of paneling adjacent to the windows to the south is missing completely and should be restored.

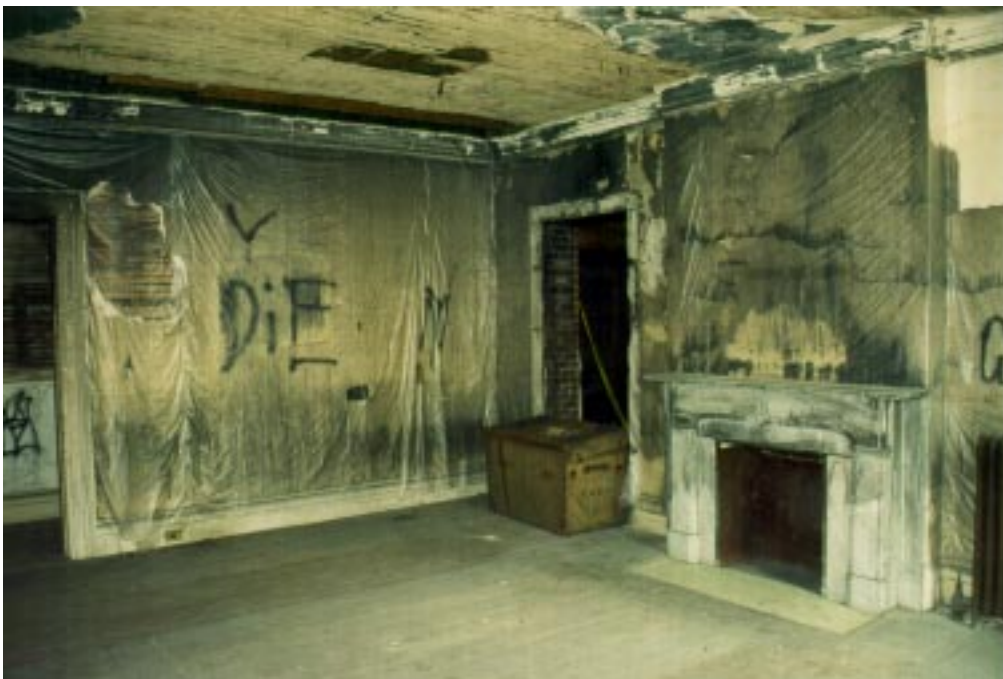
The southeast corner of Mrs. Kinkead's Morning Room. The door on the left leads to the Passage and the door in the middle led, at one time, to a dressing room. Note the band of block parquet flooring at the perimeter of the room, the marble chimneypiece and the tile hearth.

The Morning Room was severely damaged by the fire, particularly the ceiling. Damage from water and soot mars the other finishes. A fireplace is positioned near the center of the south wall, between a window and a door. The chimneypiece (46-3/4" high) is a white/grey marble with pilasters and a flat arch as defining features. A mantelshelf extends the length of the fireplace. The firebox is lined with a patterned cast-iron liner. The tile hearth is recessed approximately 1" below the parquet floor that appears to have been laid in 1891 along with the other Colonial Revival floors on the main floor. The tiles are a creamy yellow and gray, 2-1/8" x 6", with a double fleur-de-lis design. The hearth tiles are 1" x 4-1/4". A radiator stands to the right of the fireplace.

The walls were finished with flat plaster and covered with wallpaper, which can still be seen. The pattern is a small and delicate vine. A run plaster cornice, similar to the remains in the Passage, was damaged, but can be cleaned and repaired when the ceiling is replaced (using the blueboard system). The floors should be refinished taking care to preserve the parquetry around the perimeter in the Morning Room.

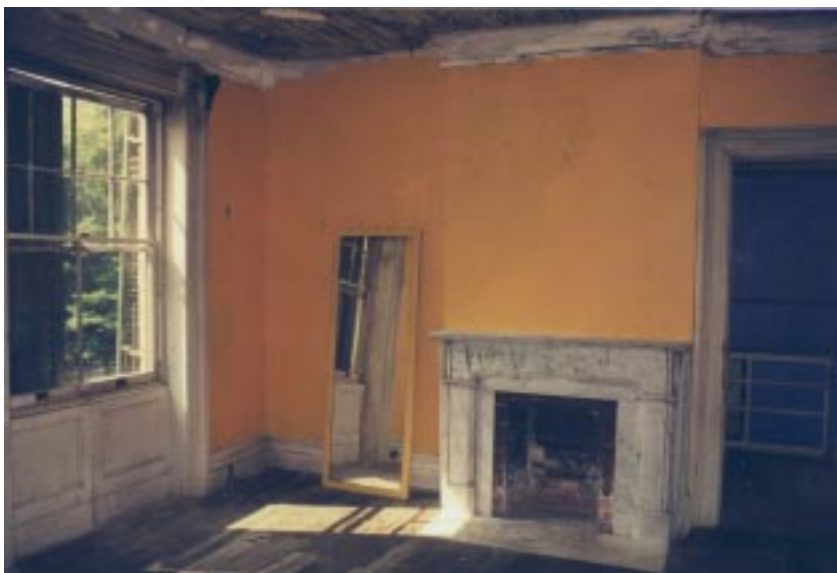
Above right: The northwest corner of Mrs. Kinkead's Bedroom. The marble chimneypiece, although of the same style as that in her Morning Room, is smaller. To the right in the photograph is a closet. Note the double panel apron under the window to the left and the damage to the run plaster cornice.

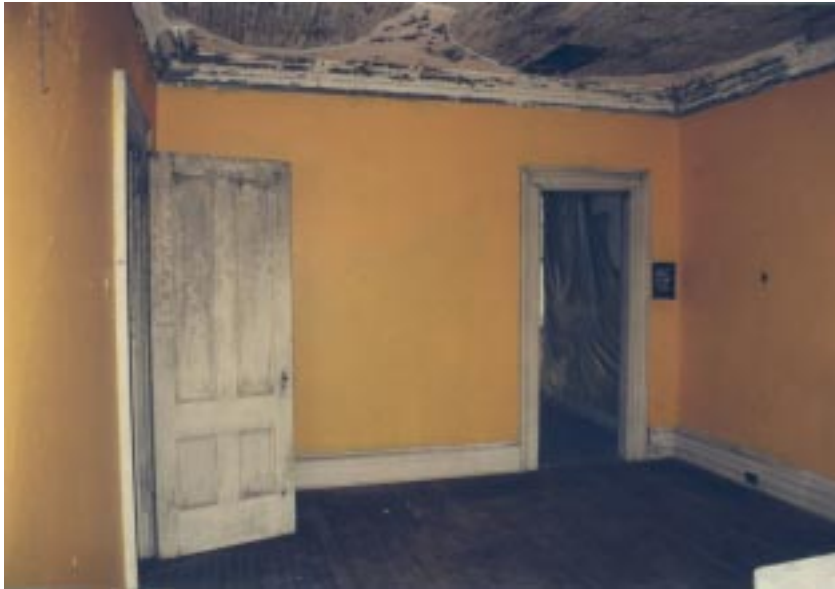
Right: The southwest corner of Mrs. Kinkead's Bedroom. The door on the right leads into the Morning Room and on the left leads out to the Upper Stair Hall. A considerable portion of the ceiling was damaged during the 1985 firefighting efforts.

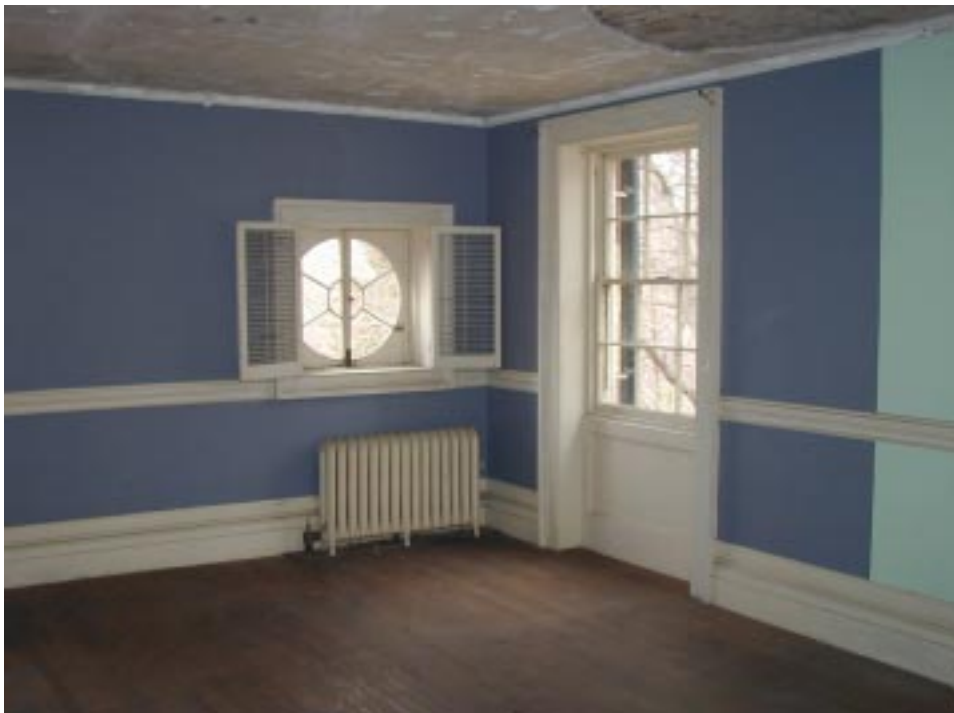
Northwest corner of North Wing bedroom. Note the square-framed circular window and the apron beneath the north window. In the upper right corner, the plaster of the ceiling is missing.

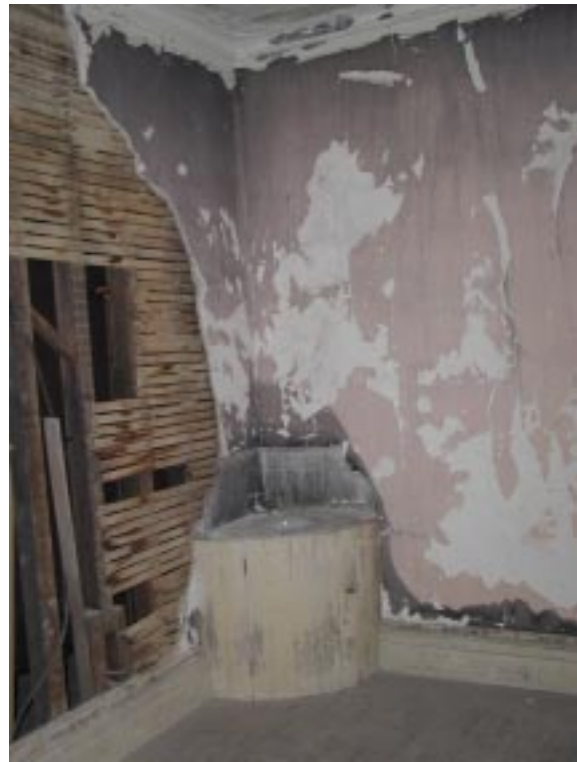
The small corner sink in the Guest Room has a marble countertop and backsplash with a curved wood-slat cabinet beneath. Note the condition of the plaster to the left. It should be replaced using the blueboard system as the damage is extensive.

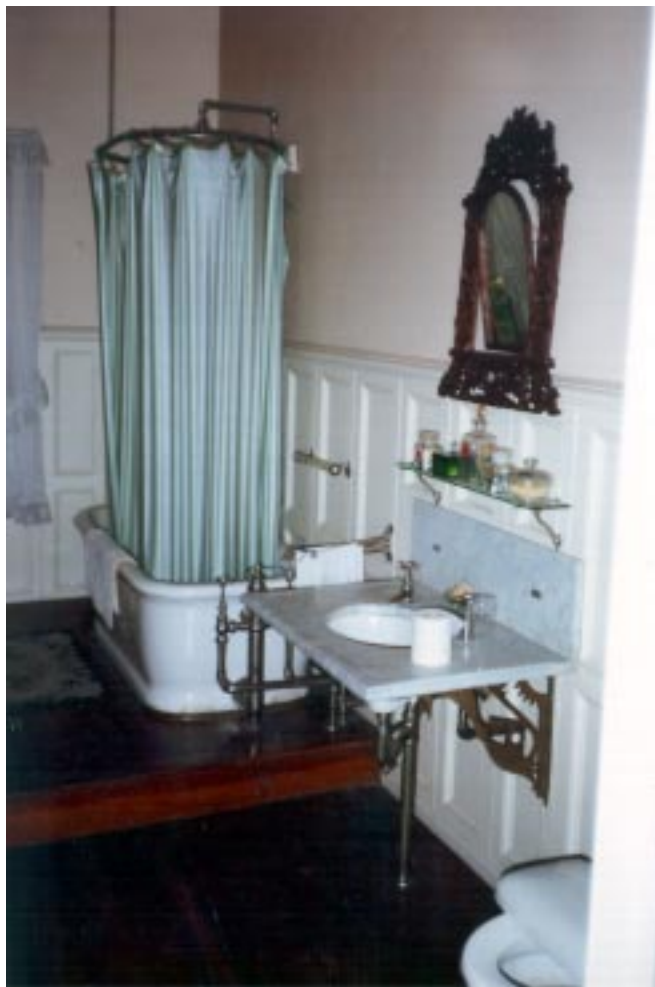
Bathroom as pictured in a photograph taken before the 1985 fire damaged the room considerably. The blueboard system should be used for the wall repair and the paneled wainscoting

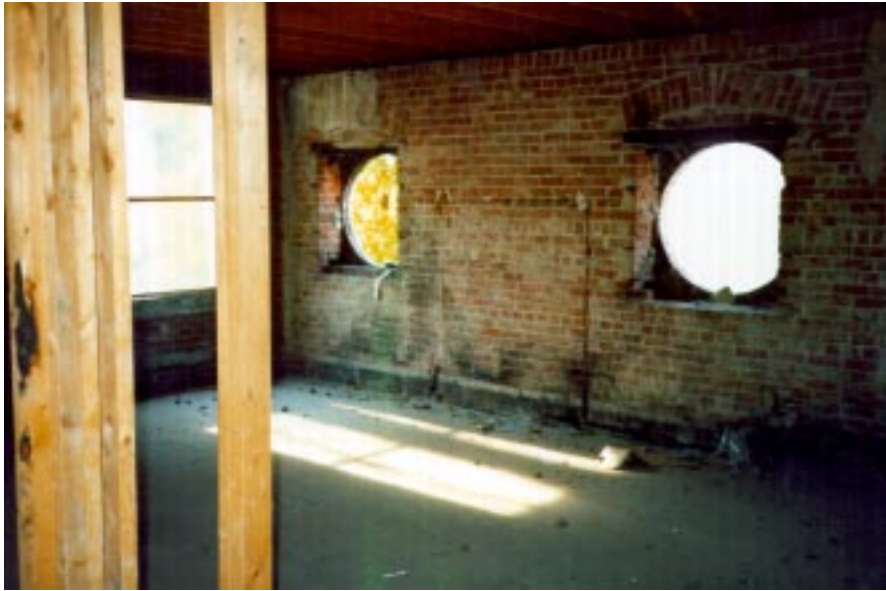
West wall of South Wing. Note the circular and square masonry openings made possible by the cavity wall construction employed at Maple Grove. All the windows should be restored and the blueboard system used to finish the room. A fireplace is located to the left of the double-hung window seen through the studs in the foreground.
