Appendix B

Room Descriptions

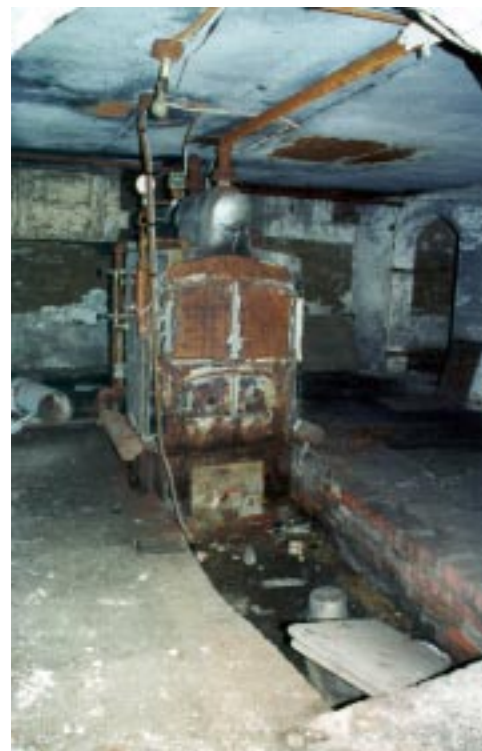
Maple Grove was retrofitted with a central coal-burning furnace to supply steam for radiators in the house.

B01 will be used again as a boiler room as it is bounded on three sides by masonry walls, which are ideal as fireproofing. However, it must be equipped with fire-rated doors and a two-hour gypsum board ceiling to comply with the New York State Fire Protection Codes.

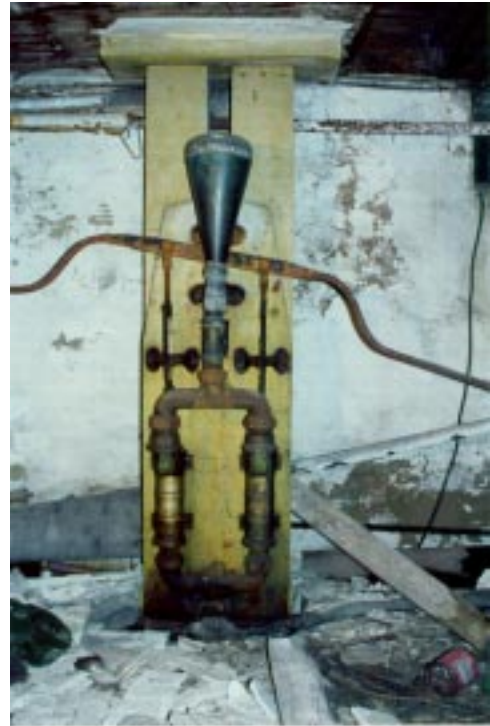
Water pump installed in the late 19th century. Note the unique double-arm pump mechanism.

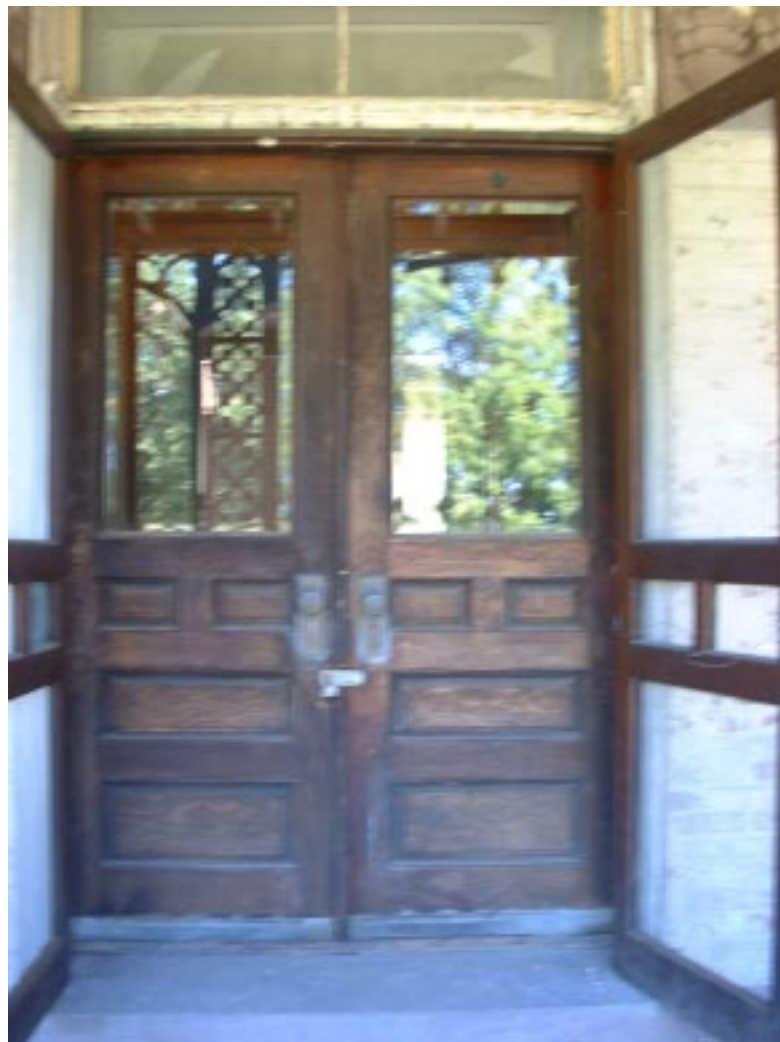
The main entrance to Maple Grove was re-configured in 1891. Paneled doors with beveled glass open into a small vestibule and the house is entered through another set of paneled doors. Note the transom light above the doors.

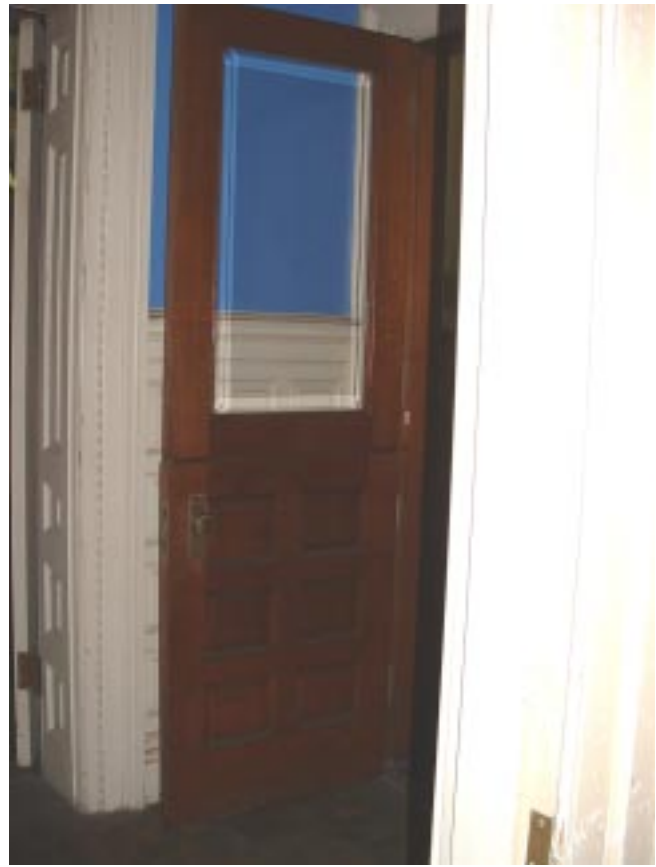
The inner vestibule doors are similar to the exterior doors except that they are split in the middle and latched, similar to Dutch-style doors. Note the door architrave with its attenuated bead.

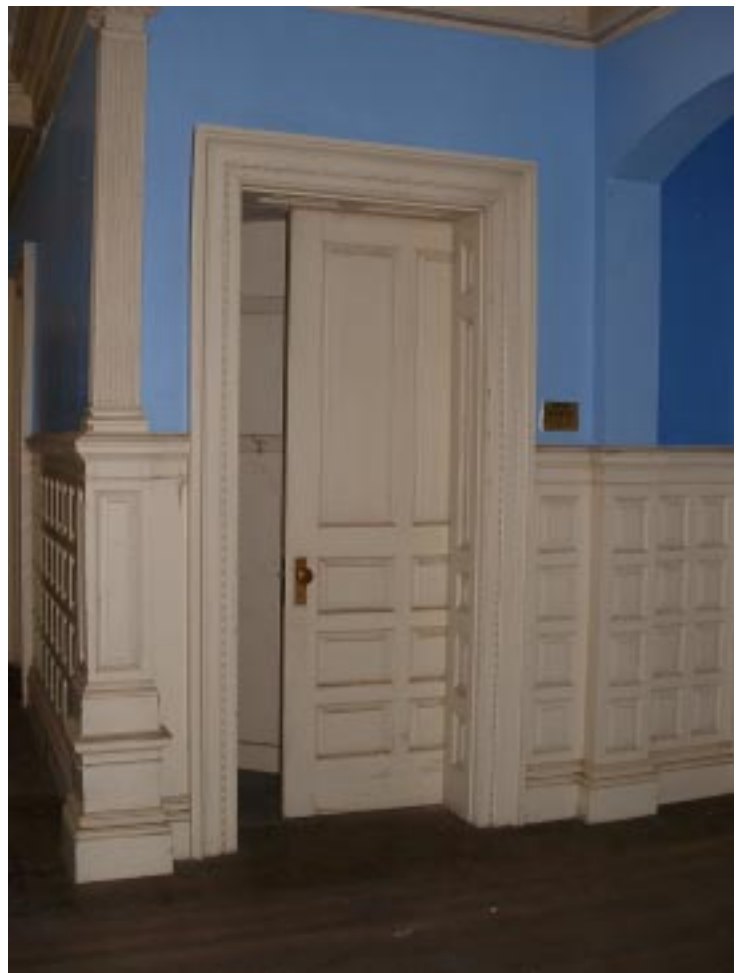
Pocket door at the end of the Passage opens onto a closet with a curved wall. The wainscot runs along all the walls of the Library and Hall as well as the Passage. Note the corner column is fluted above the dado rail. The door architrave is the same as that in the Vestibule.

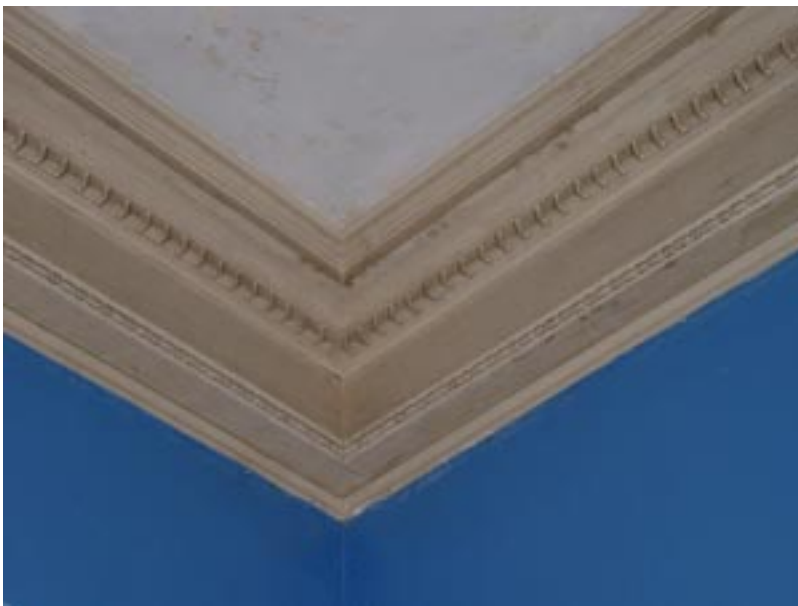
Crown molding in Passage is carried through into the Stair Hall and Library. Note the graceful relief of the patterning. The wood cornice remains largely intact.

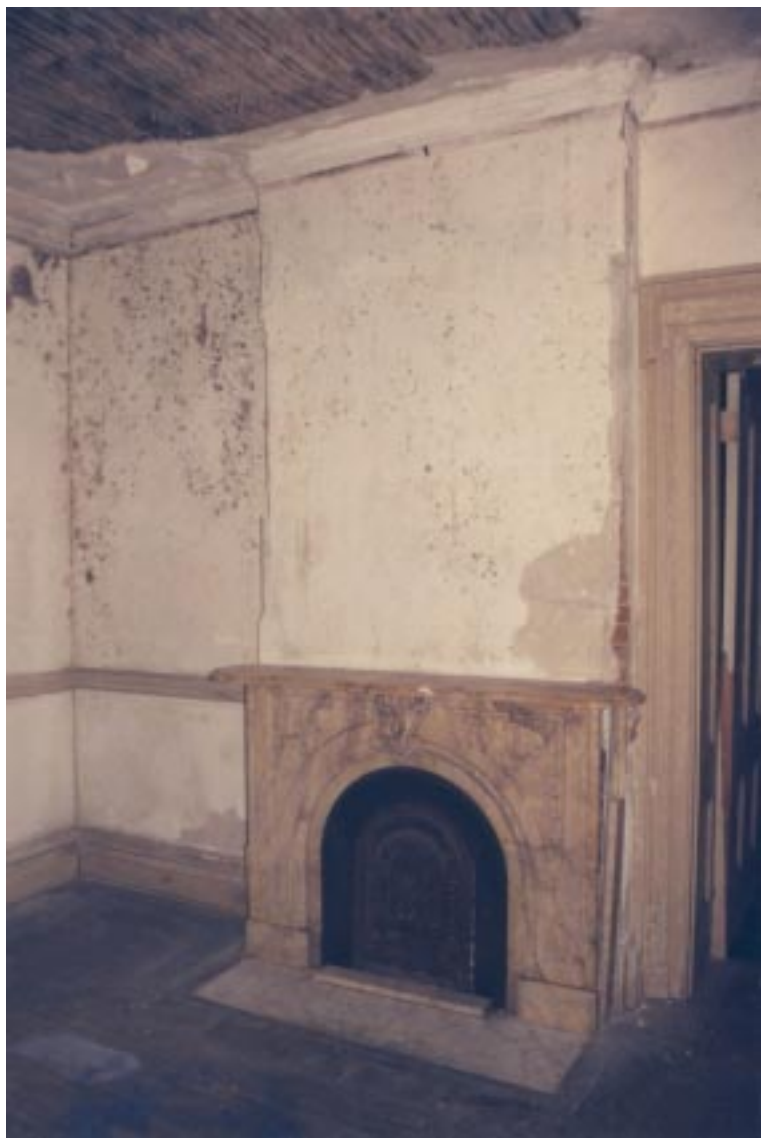
The Reception Room's warm marble chimneypiece lends an elegance to the intimate space. A block parquet floor was added in 1891 to tie the room into the Colonial Revival scheme.

The Reception Room was used in 1850 perhaps as an office for the farm operations and later as a room in which to have intimate gatherings and conversation. The cornice is in relatively good condition, but does need attention and repair. The ceiling, on the other hand, will require extensive patching by the three-coat method.

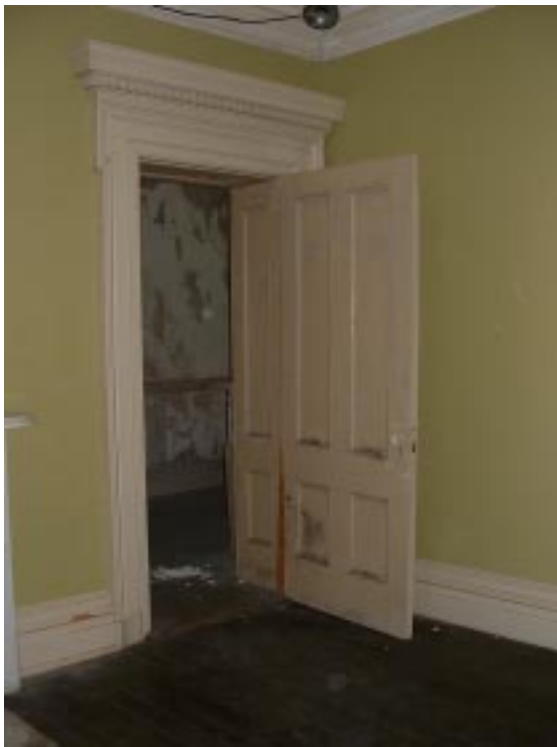
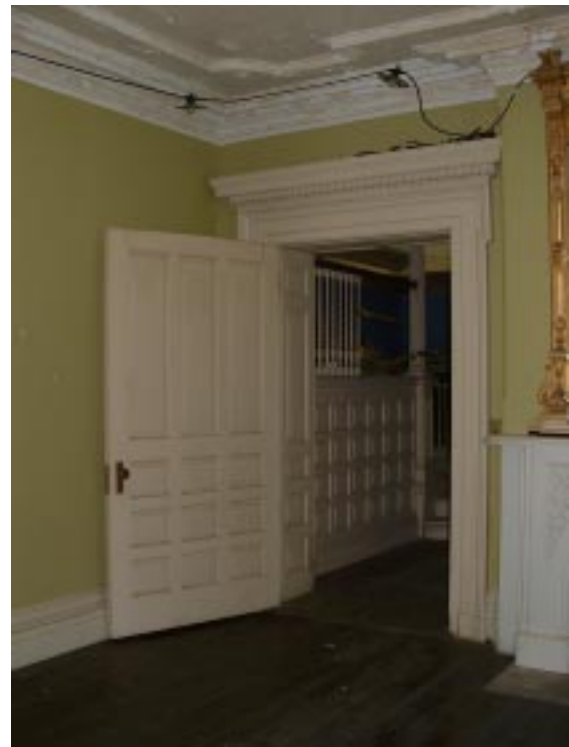
Above left: Door to the Reception Room. Note the four-panel door; the porcelain doorknob and the complimentary jamb paneling; these were common decorative elements in the early to mid-19th century. Also note the elaborate baseboard molding. Above right: The door to the Stair Hall. The multi-panel door compliments the jamb paneling and the paneling in the Stair Hall beyond. Also note the dentiled cornice placed above the dog-eared architrave and the metal doorknob. The 7/8” difference in floor height is visible at the saddle in both views.

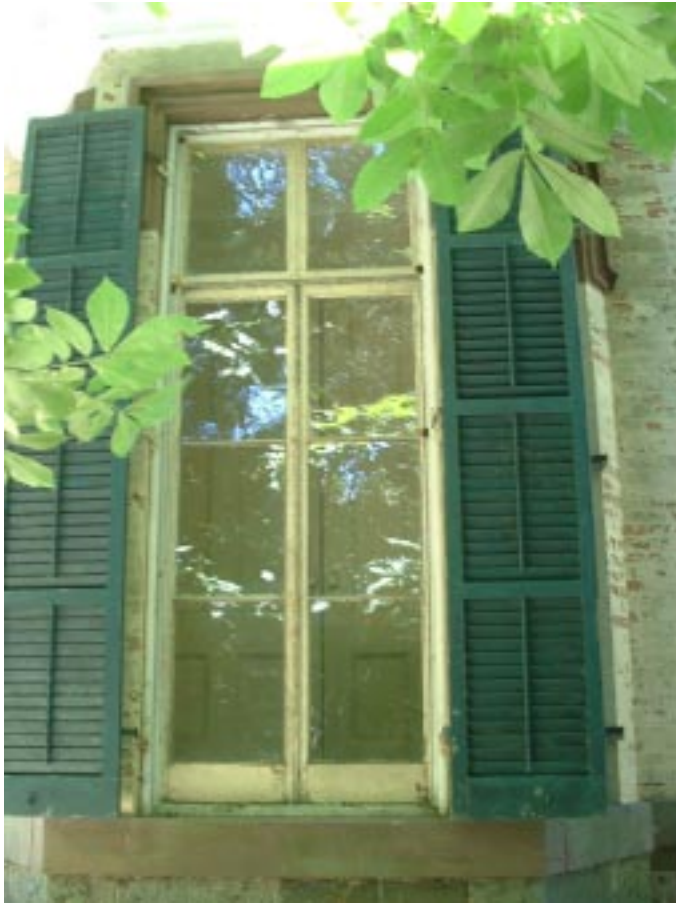
Exterior view of the bay window on the north end of the Grandparent's Parlor. Note the full-height casement windows which originally adorned the entire west facade as well as the east opening to the northeast verandah off the room.

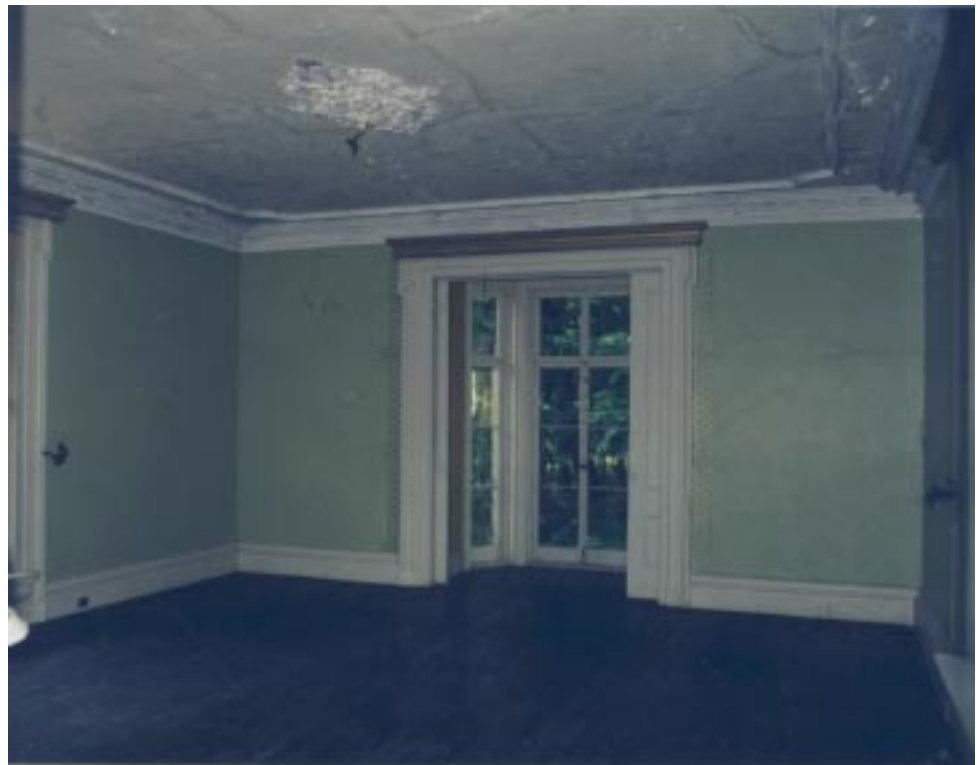
Below: an interior view of the bay window in the Grandparent's Parlor. Note the deep run plaster cornice, the dog-ear architraves, the gold-leaf valences, the ceiling medallion and the pocket doors.

The walls of the Grandparent's Parlor are finished in flat plaster that is in good condition. Minimal repair of cracks on the walls and ceiling are necessary. The plaster walls extend up from the baseboard to the cornice, or crown molding, that hugs the perimeter of the room. The baseboard molding is 12" high. Although the high-style Greek Revival run plaster cornice is in good condition, there are areas of repair required. The cast plaster medallion at the room's center requires repair at one end and measures 36" x 24".

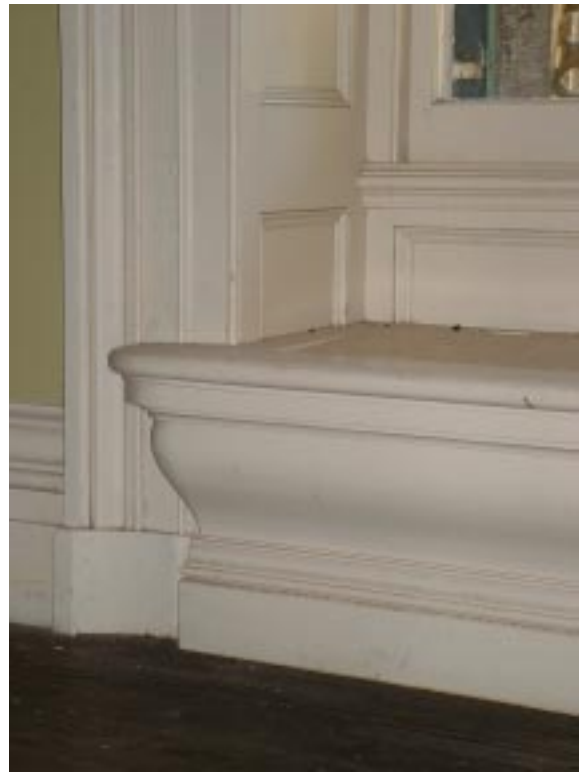
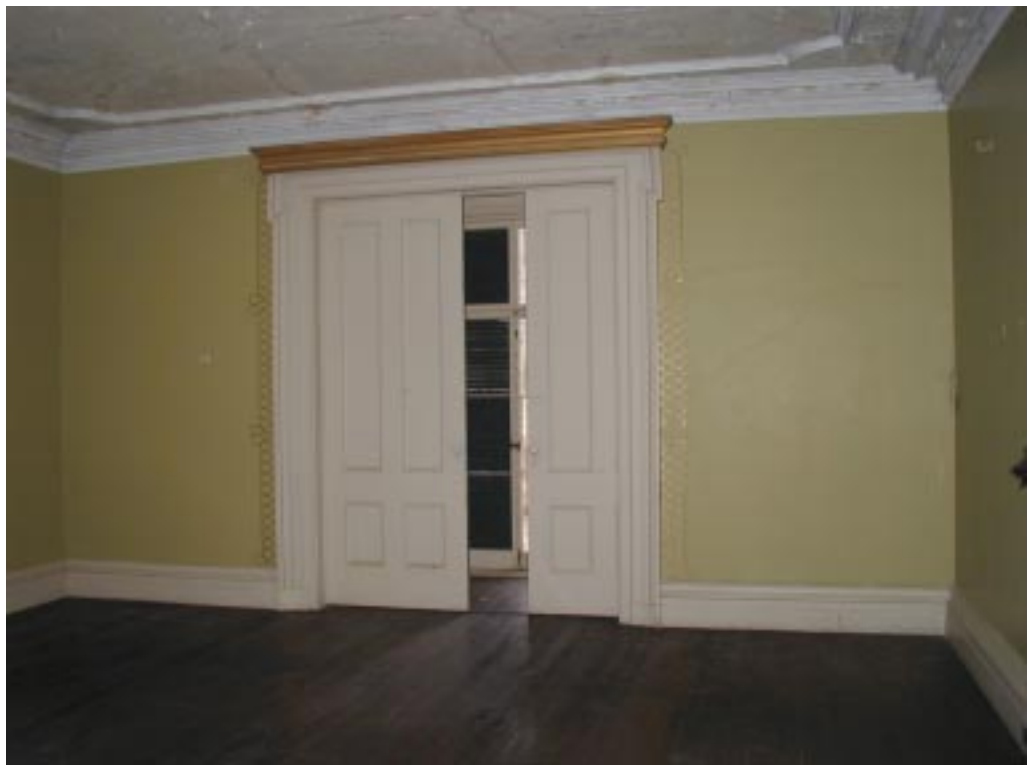
Right: Window seat on the west side of the Grandparent's Parlor. Note the graceful curve under the seat and the paneling on the window jambs.. The panels behind the seat are full size.

Below: View of pocket doors when closed. The four panel construction is typical of the doors used in the original 1850 phase.

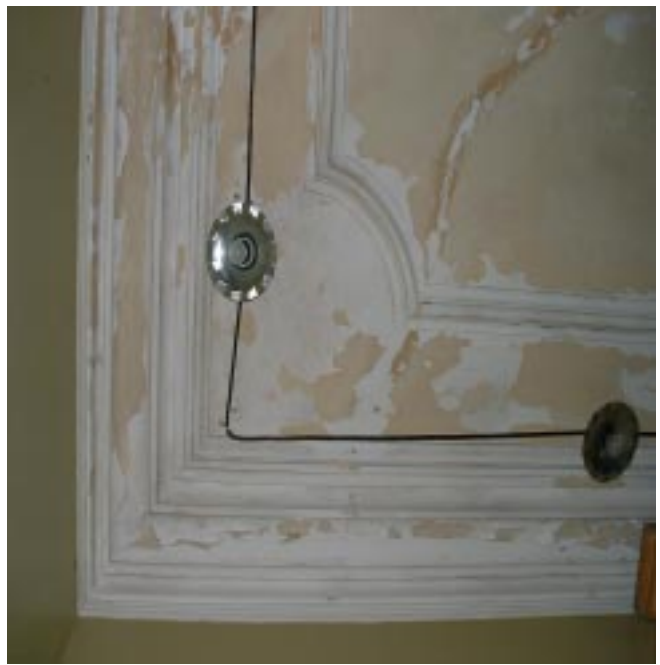
Detail of the Greek Revival cornice northwest corner of the Grandparent's Parlor. Note the deep cove between the two outside bands and the bolection molding with convex curves marking the corners.

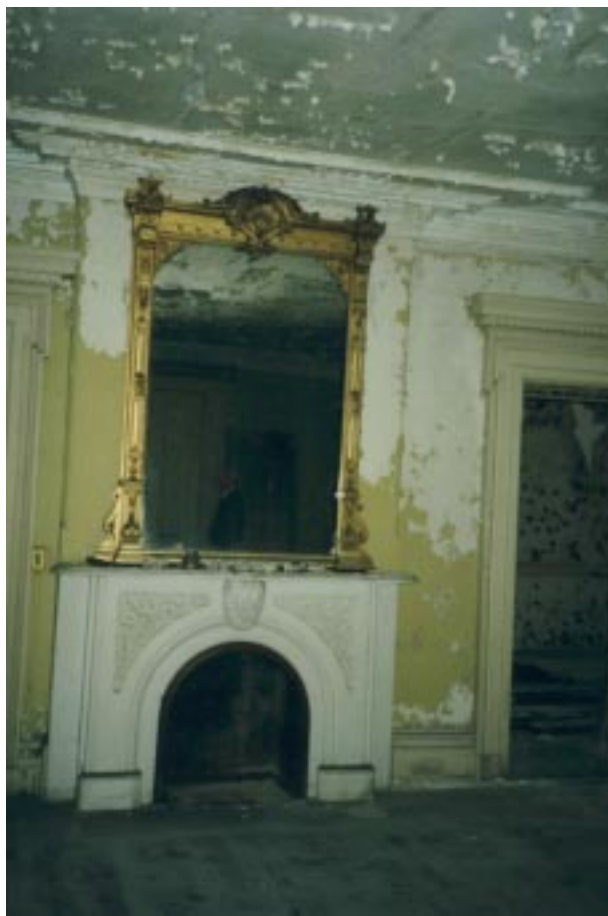
The white marble chimneypiece in the Grandparent's Parlor is complimented by a gilded Renaissance Revival mirror. The fireplace hearth is a darker marble, set flush with the floor. The mantelshelf is approximately 4' high.

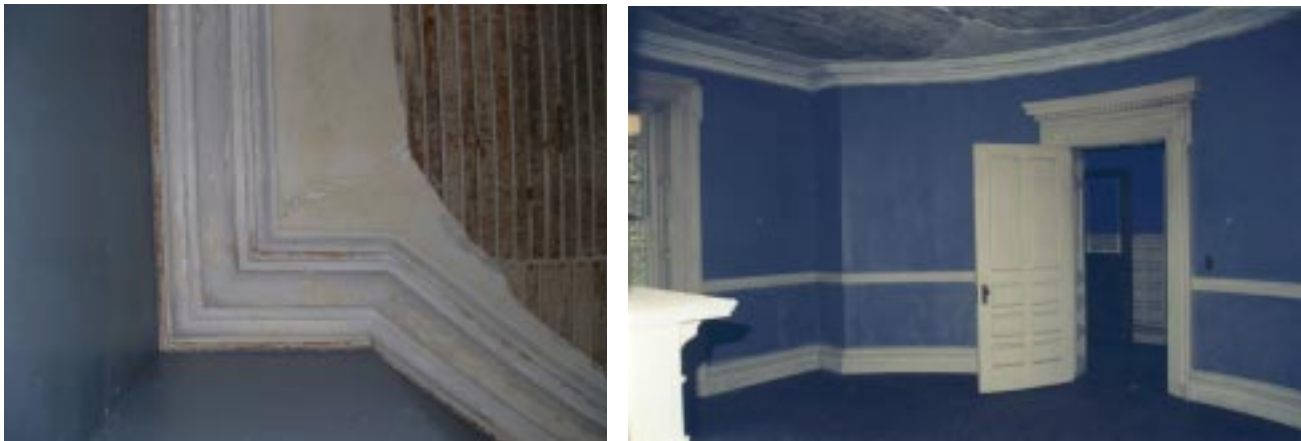
Right: Detail of the cornice molding in the northwest corner of the Drawing Room. Note the beginning of the graceful curve of the wall and the deep cove between the two bands. Left: The northwest corner of the Drawing Room. The curve of the wall allows for a small closet in the Vestibule. Note the dog-ear architraves surrounding the doors and windows and the Colonial Revival cornice additions with dentils applied in 1891.

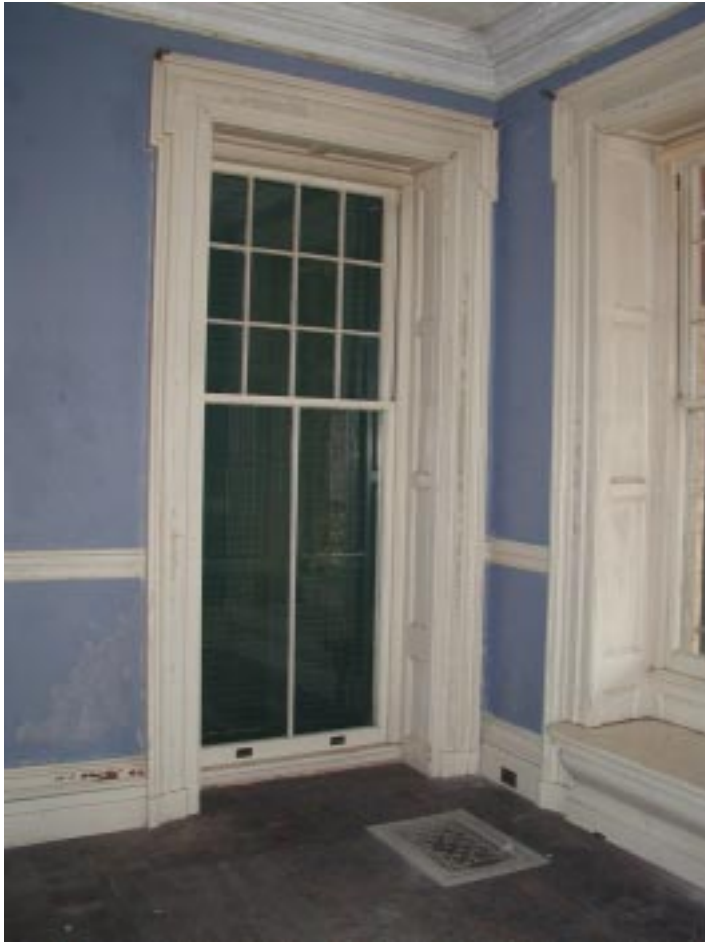
Right: 1990s photograph of southwest corner of Drawing Room. Note the paneled window jambs, the dog-ear window architraves and the multi-lite upper sash in the windows. Visible in the lower right of the photographs the floor register near the corner that provided heat to the room after 1891. The window sash measure 50-1/2" x 45" (lower) and 50-1/2" x 43" (upper) for the west window and 64-1/2" x 40" (lower) and 43" x 40" (upper).

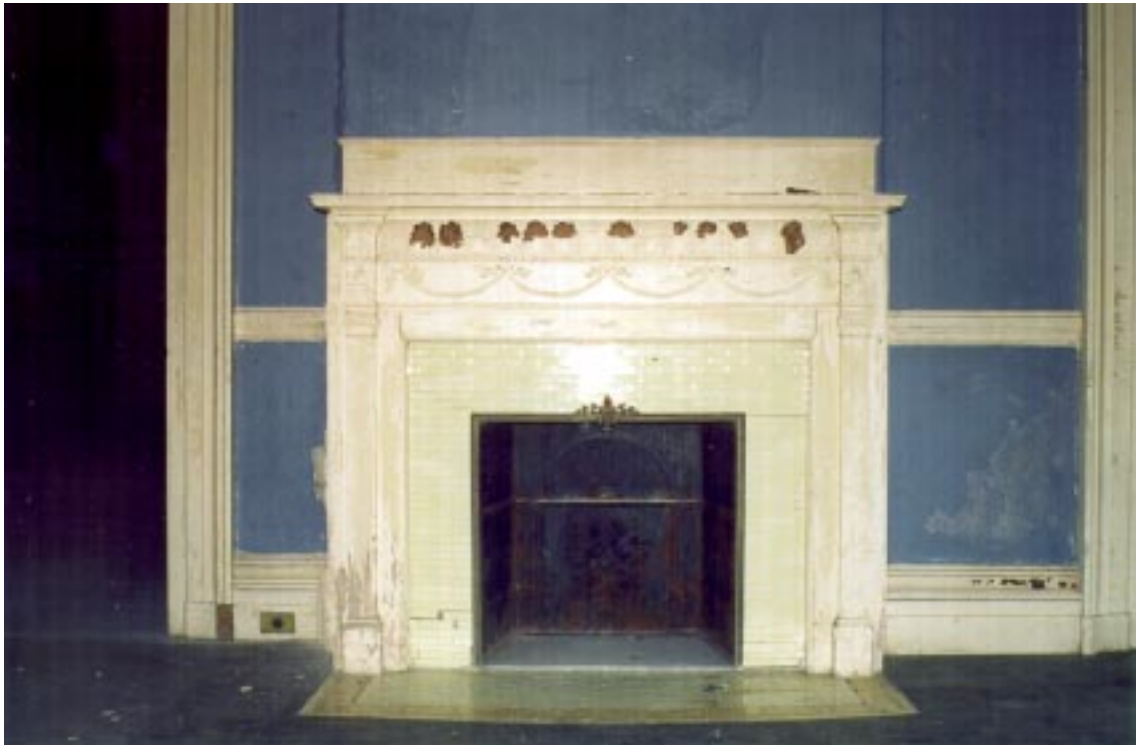
Below: 2001 photograph of the Drawing Room fireplace. Note the Colonial Revival elements of the chimneypiece: the Adamesque swags, the attenuated columns, the tile slips and the frieze board above the mantelshelf. Also note the similarity between the moldings in the Drawing Room and the Reception Room from 1850.

of the way up the wall, ending in a deeply coved Greek Revival cornice. The ceiling, too, is flat plaster with a central cast plaster medallion. The walls are generally in good condition and need minimal repair work. In contrast, the ceiling plaster is almost completely missing as is the medallion. Both the preceding elements should be repaired or replaced.

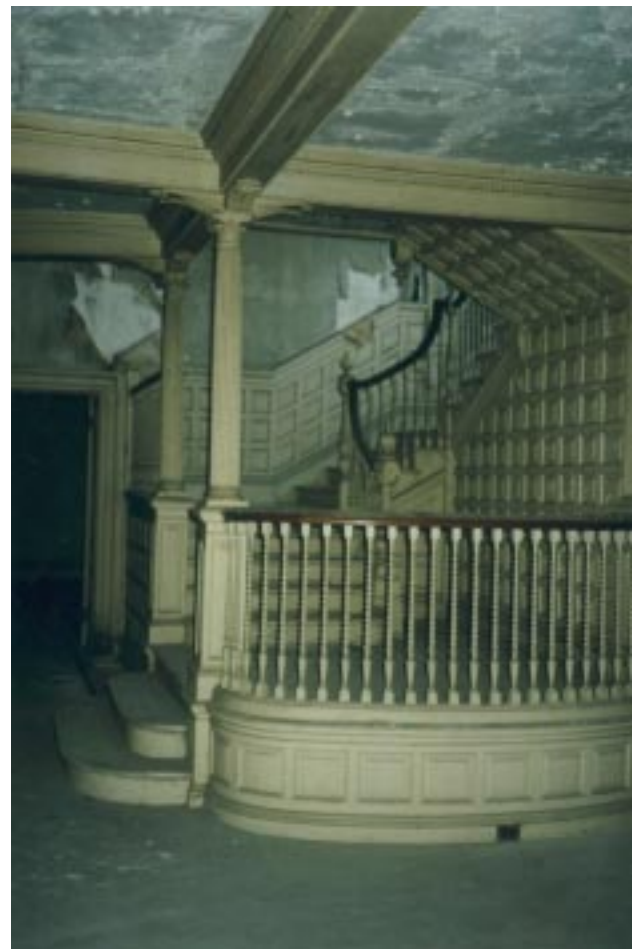
The curved landing of the staircase provides a small seating area that overlooks the Library. Note the sweep of the handrails from the landing, the wainscotting that follows the stairs, the fluted columns and twist-turned balusters. The walls above the dado were originally papered as seen on the north wall pictured here.

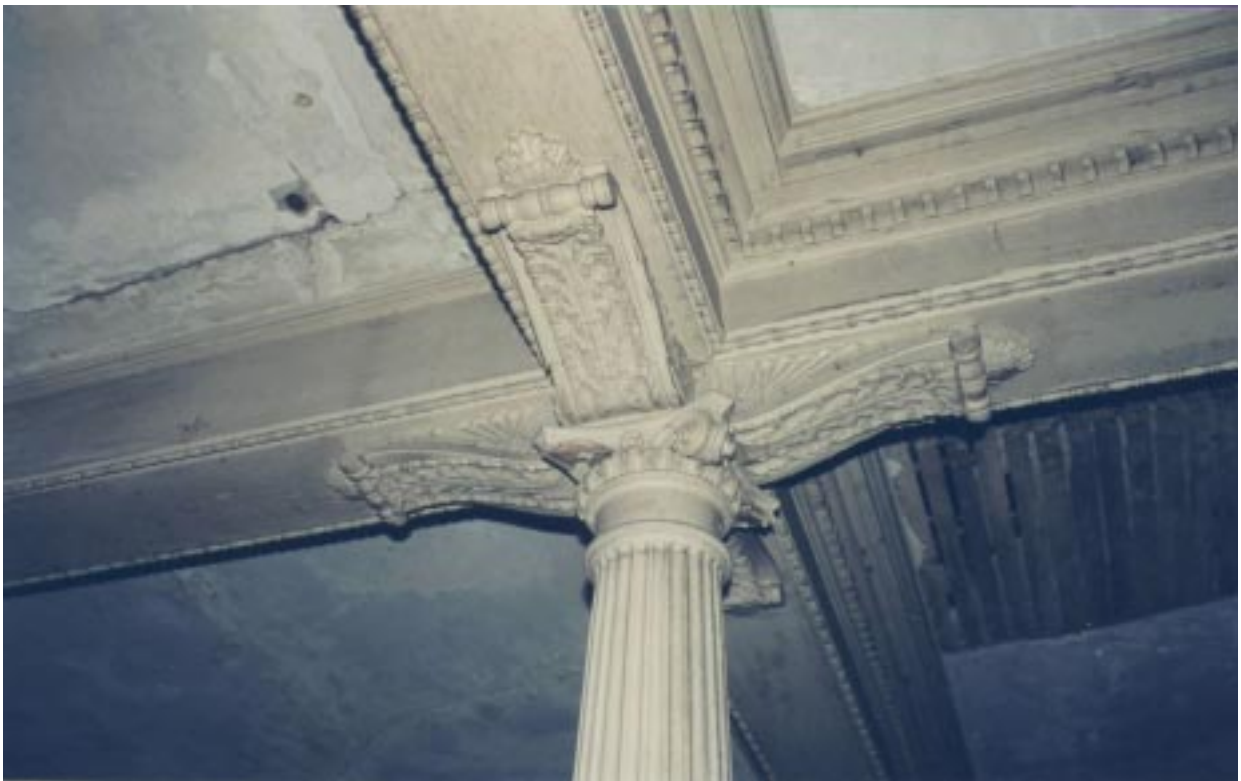
Also characteristic of the Colonial Revival period is the use of a window to illuminate a landing at a turn in the stairs. The tri-partite elliptical head window employs fluted columns to separate the double-hung windows (the flanking window are narrower than the central window) that rise to the entablature over which a fanlight is placed. The implementation of the opening added much needed light to an

The fluted columns are crowned by a version of Composite order capitals with small Ionic scrolls below larger horizontal brackets in the shape of acanthus leaves. They appear to support the beams, which reflect the profile of the cornice. The woodwork is quite delicate and must be restored in several areas.

otherwise dark stair hall. The section of paneling adjacent to the windows to the south is missing completely and should be restored.

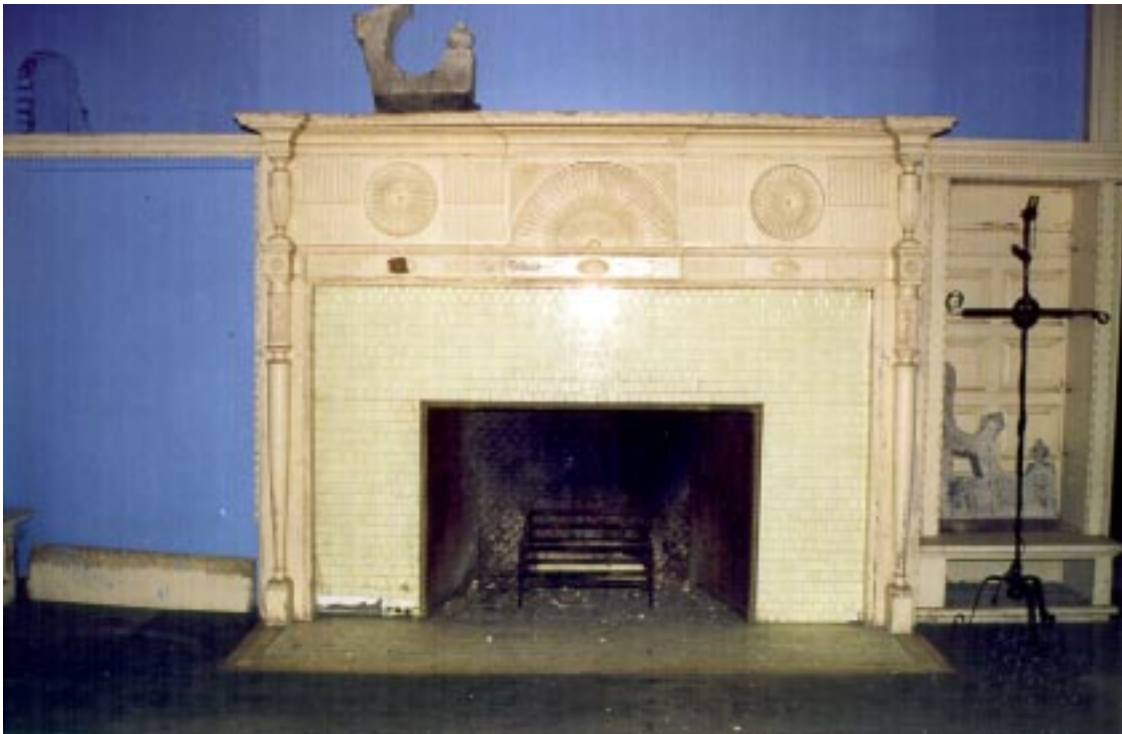
The fireplace dominates the living hall space of the Library. The delicately carved chimneypiece extends inches above the line of the dado rail. Tapered cylindrical columns rest on small plinth block and extend up to the carved entablature. A broad frieze panel incorporates roundels and a fan pattern as its focal elements with a dentilled cornice. Creamy yellow glazed tiled, 2-1/2” square, are used for the slips and hearth. The hearth is trimmed with a band of 1/2”x 4-1/4” reddish gold tiles and a second band of 2-1/4”x4-1/4” yellow tiles with a floral pattern and is flush with the parquet floor. A cast-iron liner was inserted into the firebox.

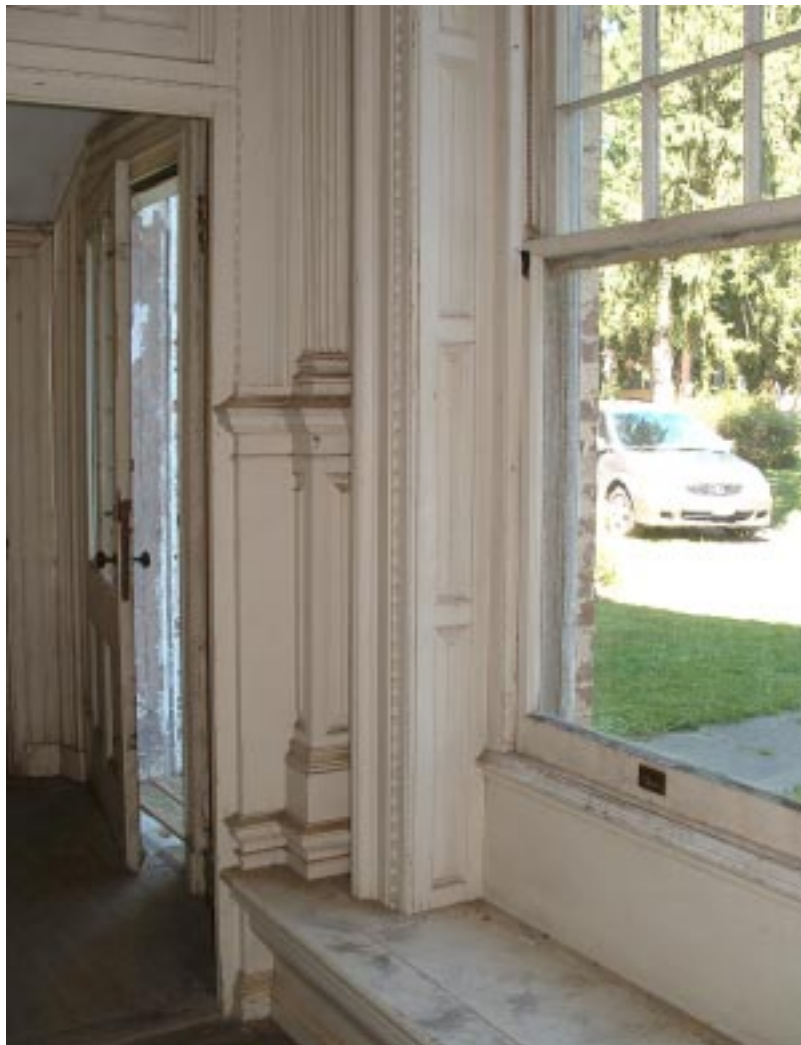
View into the back Vestibule past the east windowseat. Note the jamb panels. Although the east brick masonry wall is equal in thickness to those surrounding the other windowseat openings, the jamb panels are considerably narrower perhaps owing to the use of the fluted column seen to the left of the jamb. The partition between the Library and back Vestibule is only 2-1/2" thick.

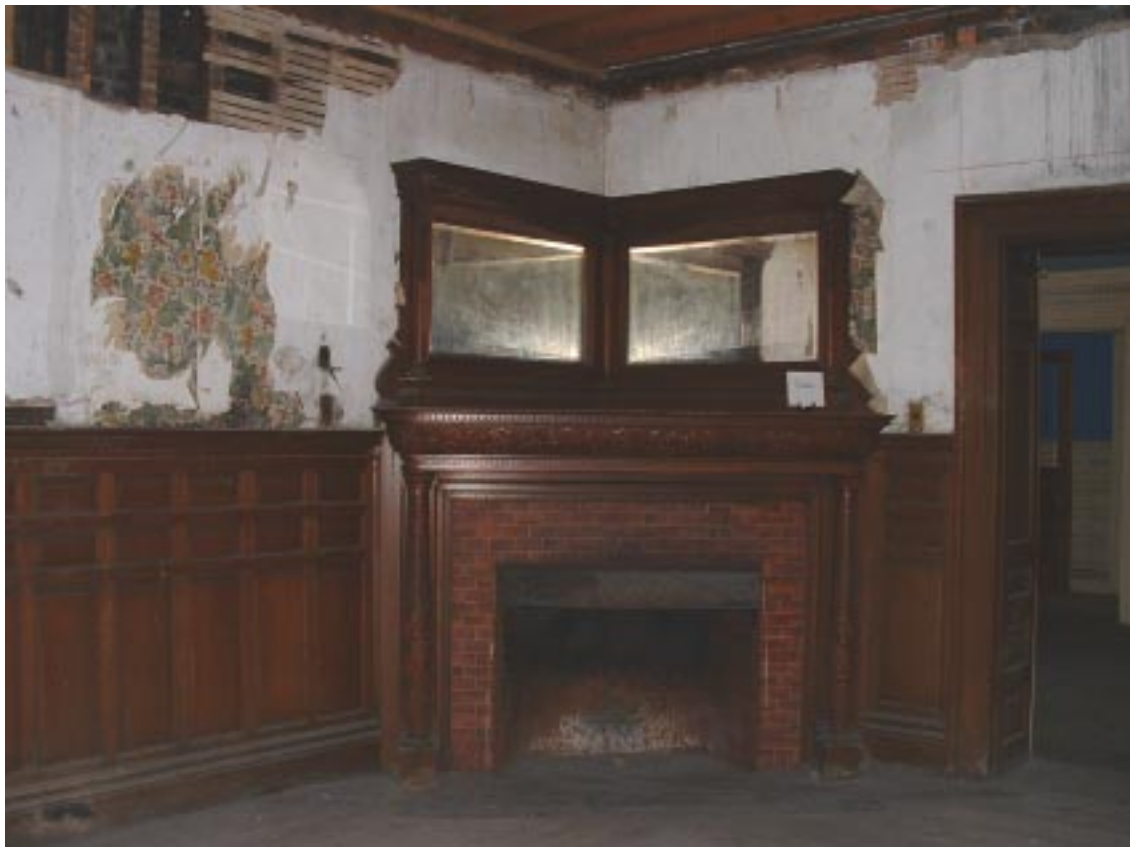
The corner fireplace installed in 1891 by the Walker firm. The oaky tones of the Dining Room created a lush impression.

The floor of the room is laid with 2-1/2" strips of wood in an perpendicular pattern. The ceiling was destroyed with the most of the cornice. Fortunately, the corner fireplace was preserved. The cornice of the chimneypiece is supported by two columns with leaf-like lower portions and twist-turned uppers. A dentil course serves as the architrave of the cornice with the cyma recta elaborately carved with grapevines and finished with another dentil course. Above the mantelshelf, are two beveled mirrors set into the corner with frames and cornice. The slips are finished with brick-colored tiles. The firebox liner has a patterned hood that lowers the height of the box itself. The hearth is flush with the parquet floor with 2-1/4" x 4-1/4" brick-colored tile with a 1" x 6" teal-colored tile and a oak-colored fiddle-head fern pattern border.

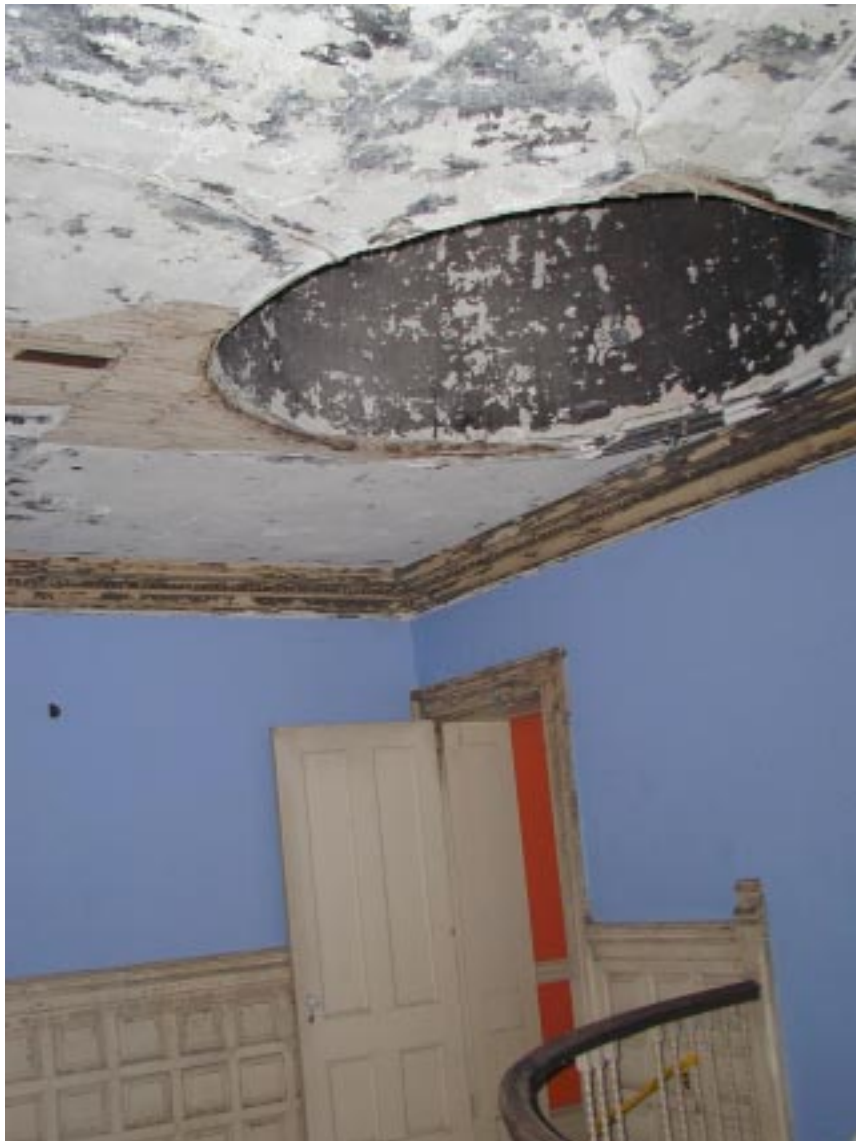
The northwest corner of the Upper Stair Hall is illustrative of the treatments existing today: the Colonial Revival paneled wainscotting, the curved balustrade, the Greek Revival architraves, the paneled jambs at the intersection of the main block and north wing, and the skylight opening.

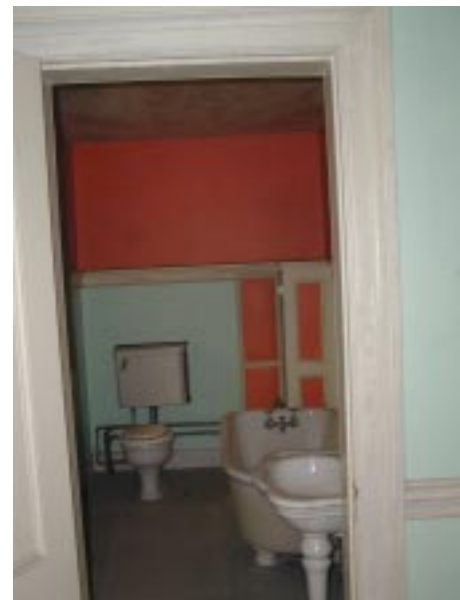
North Wing bathroom was created from a dressing room established in 1891.

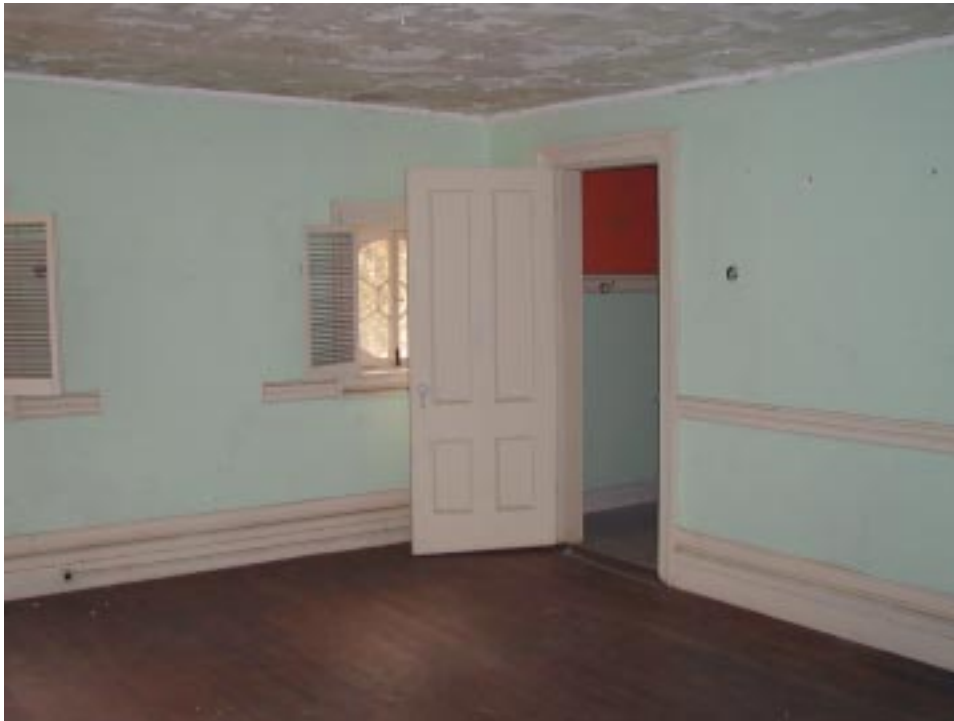
Southeast corner of North Wing with the bathroom. Note the tall very tall baseboard moldings, the break in the chair rail between the windows on the east wall and the four panel door.

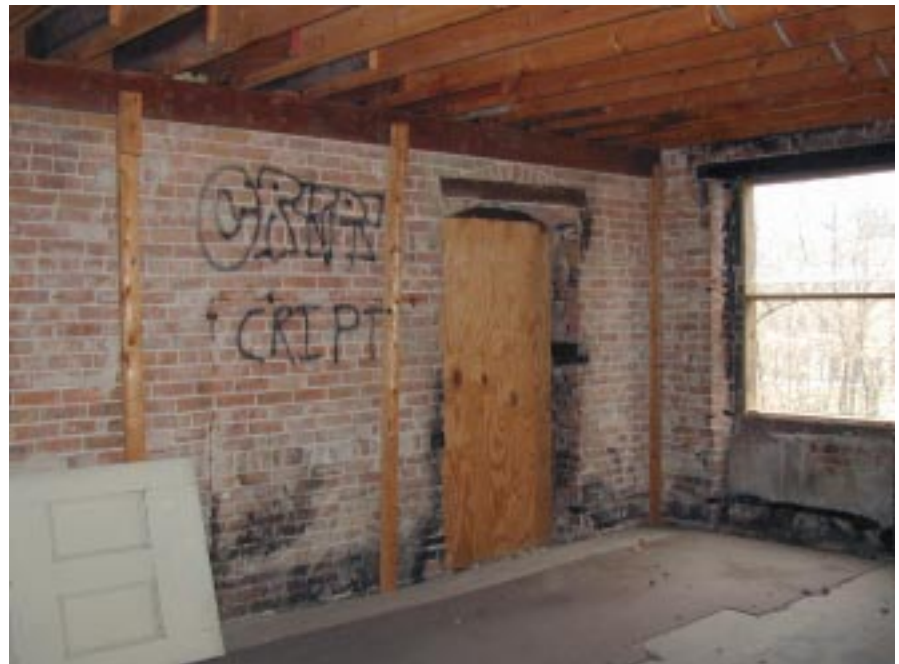
Service Wing of Second Floor-The Service Wing housed the back staircase and the servant's quarters. Little remained of the wing after the 1985 fire, but it has been stabilized: the masonry walls and roof were rebuilt and the windows were replaced with modern double-hung windows. The wing might serve well as an office and should be finished using modest means.

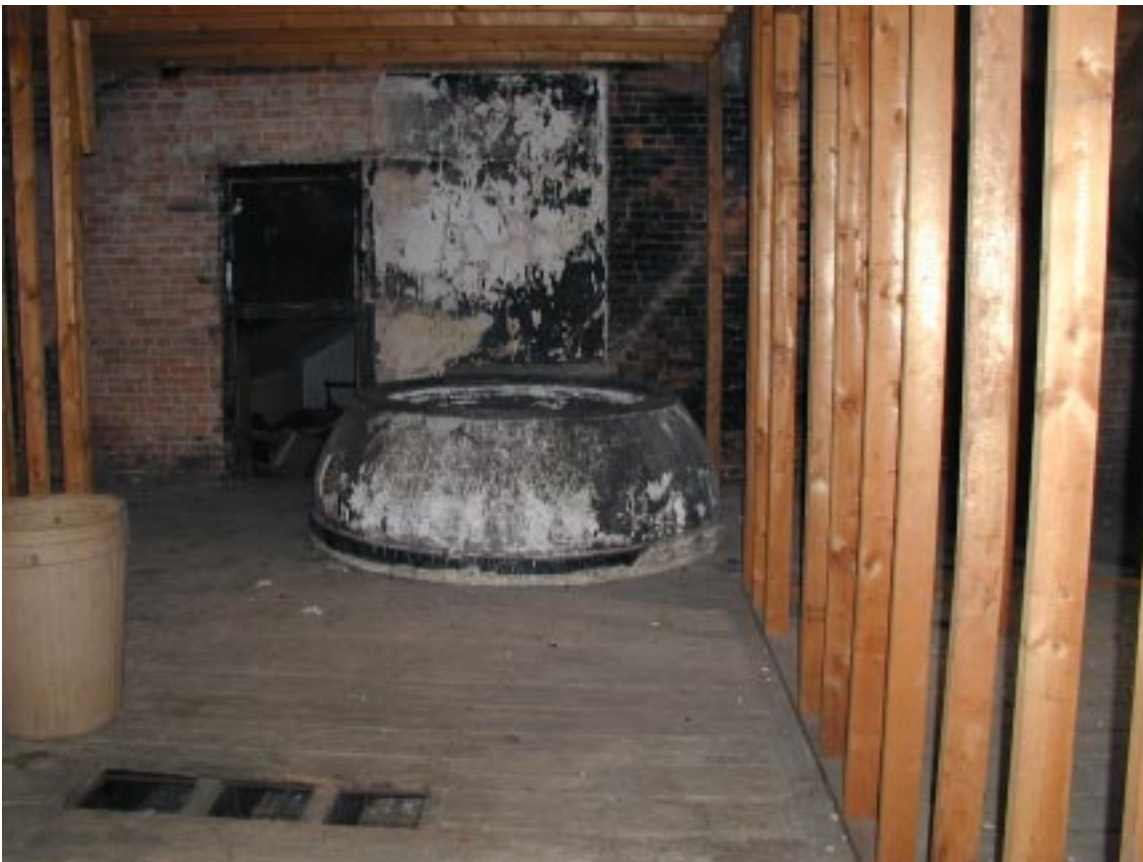
At the center of the photograph is the laylight structure, which is made of plaster and lath. To the left of the shell is the entrance to the trunk room. The cistern is located directly above the 1891 bathroom in the southeast corner of the main block.

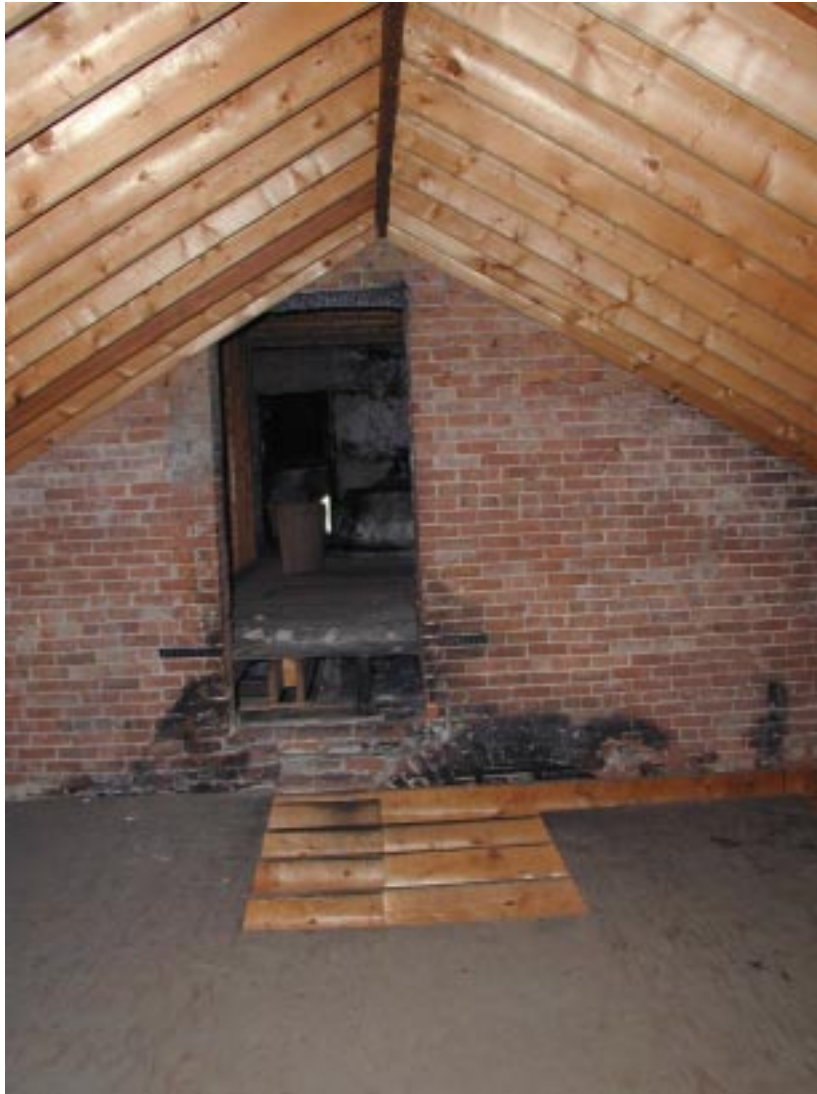
View from south attic room into main space up several steps. The service stairs ran up the brick masonry wall and arrived at the base of the opening. The floor opening visible in the photograph is used only to gain access to the attic spaces, not for the stairs.
